# WGSL Final Report for Sedimentation Basin Restoration

Please find a copy of the final report documenting the restoration of the sedimentation basin located at the Waimanalo Gulch Sanitary Landfill.

Subject: Sedimentation Basin Restoration Observation Report, Waimanalo Gulch Sanitary Landfill, Kapolei, HI

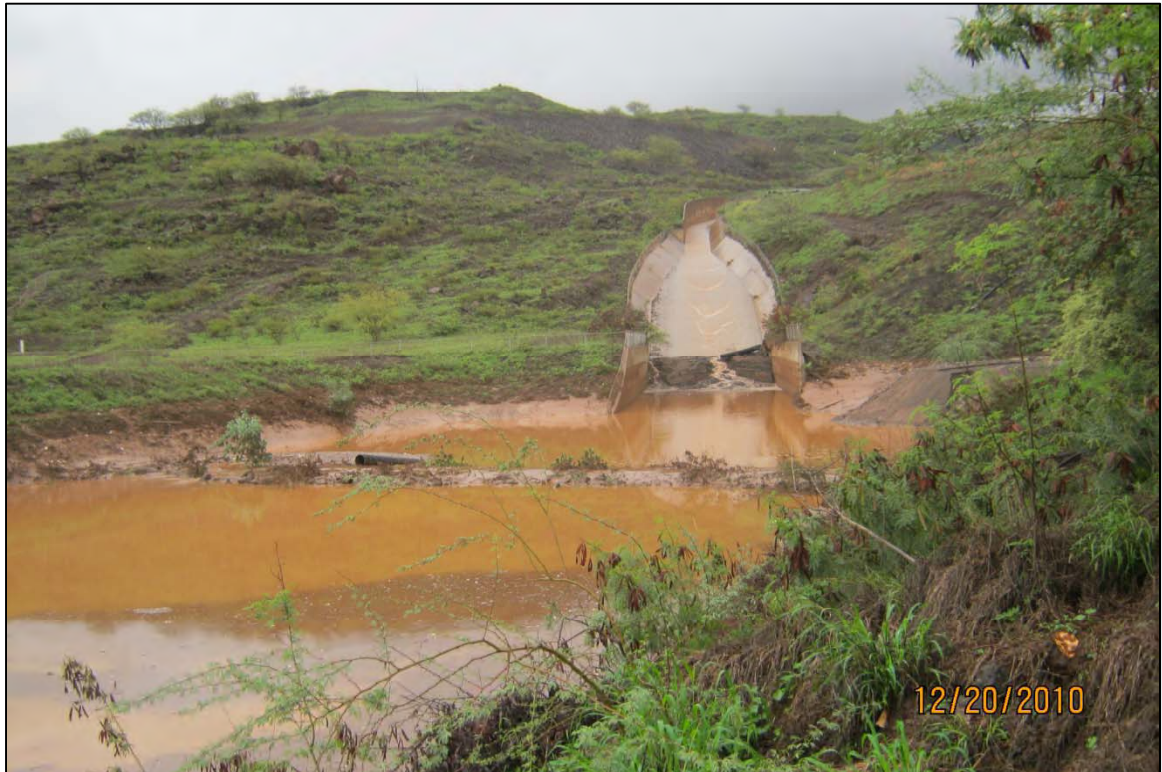
Photo 1: Sedimentation basin following December 2010 storm events, looking north.

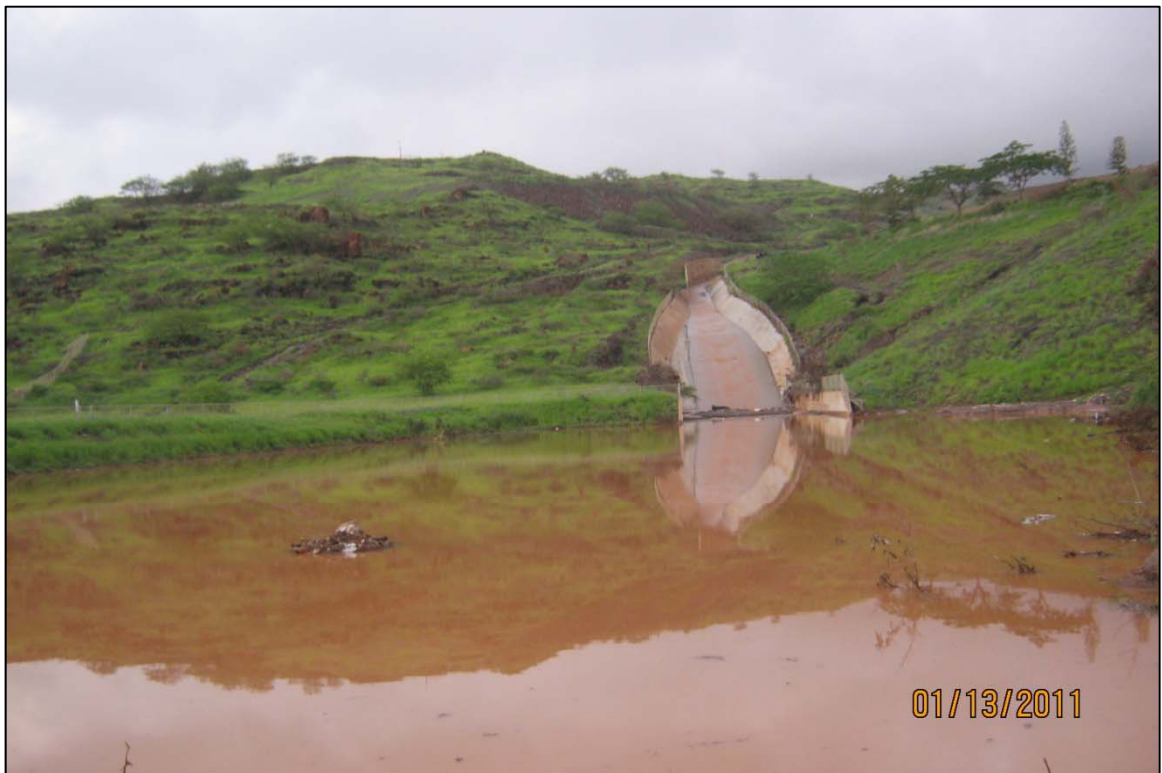
Photo 2: Sedimentation basin following January 2011 storm event, looking north.

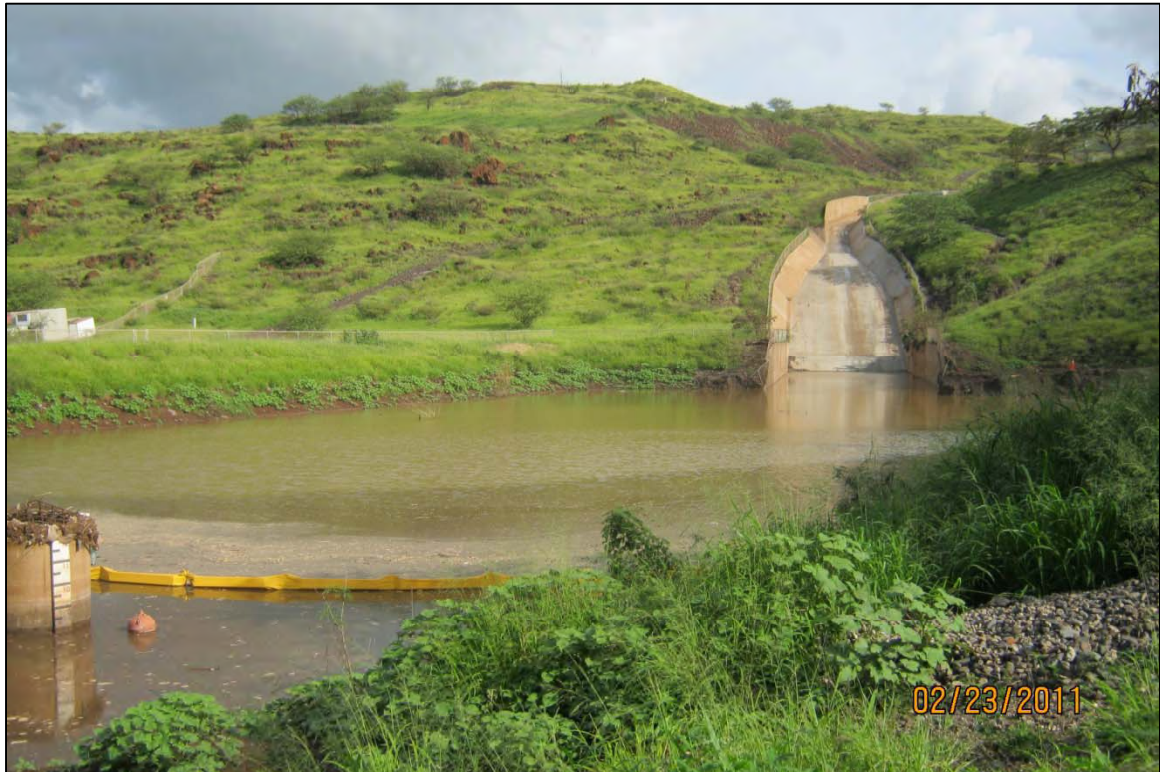
Photo 3: Sedimentation basin prior to pumping by WMH in February 2011, looking north.

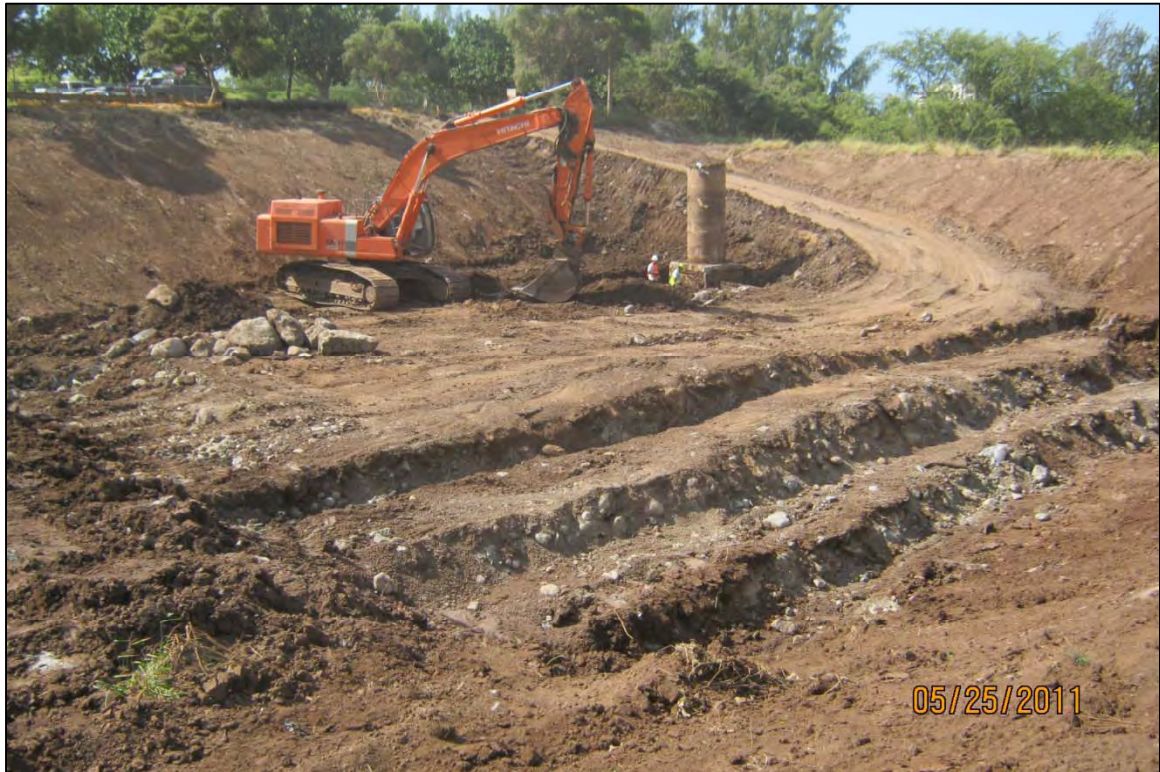
Following excavation of the sediment in the southern basin area, the subdrain trenches were exposed and the drainage gravel within the infiltration trenches inspected. Due to observed sediment within the drainage gravel around the subdrain pipes, WMH decided to replace the subdrain system and installed new 16-oz/yd<sup>2</sup> filter geotextile, 3/4-inch minus drainage gravel, and perforated high density polyethylene (HDPE) pipe.

Photo 15: Excavating the infiltration trenches of the subdrain system in the southern portion of the sedimentation basin, looking southeast towards the eastern inlet riser.

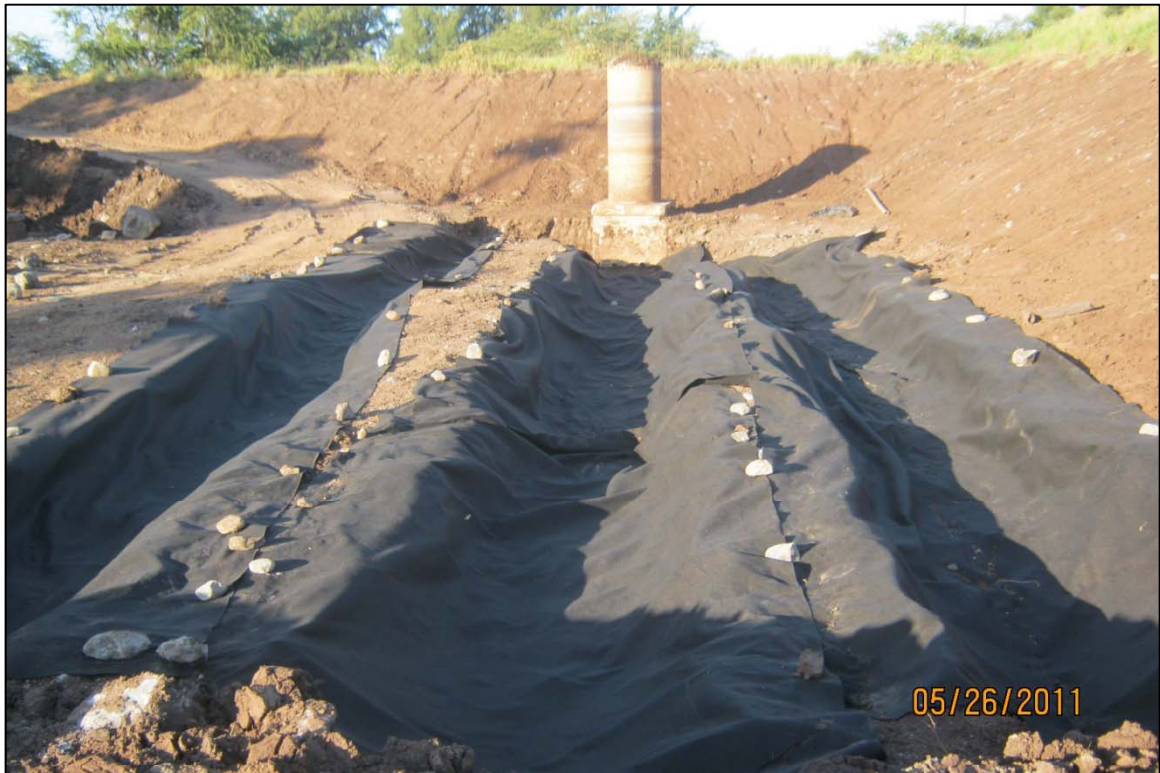
Photo 16: 16-oz/yd<sup>2</sup> geotextile deployed in the infiltration trenches of the subdrain system in the southern portion of the sedimentation basin, looking south towards the western inlet riser.

A 3/4-inch minus drainage gravel was used around the HDPE perforated pipe, encapsulated by a 16-oz/yd<sup>2</sup> filter geotextile, as shown in the design drawings included in the work plan in Attachment 1. The drainage gravel used during the restoration was an onsite generated material, similar to gravel used for the drainage layer material in the ongoing MSW cell construction.

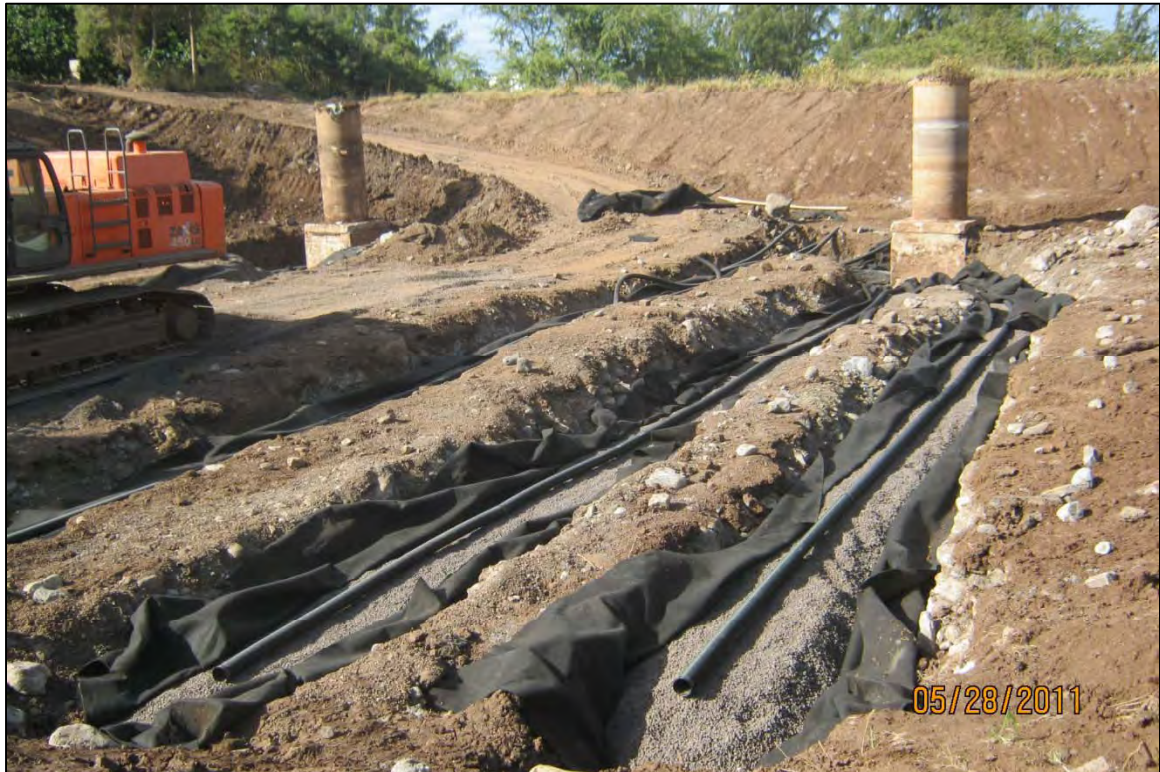
While removing the existing subdrain system, two as-built deviations from the design drawings were observed. The first deviation included the use of a 4-inch perforated HDPE pipe rather than the 6-inch noted in the design drawings. The second deviation observed was the connection of the HDPE perforated pipes to the 42-inch CMP discharge pipes. As-built connections for the HDPE perforated pipes included pre-cast openings in the concrete vaults for the riser pipes rather than the sleeve directly into the 42-inch CMP pipes noted in the design drawings. Three openings in the western concrete vault and four openings in the eastern concrete vault were observed, one for each of the seven infiltration

Photo 17: 4-inch perforated HDPE subdrain pipes placed over 6-inch thick layer of drainage gravel and 16-oz/yd<sup>2</sup> geotextile filter fabric in infiltration trenches, looking southeast.

During the replacement of the subdrain system, as-built conditions were restored including the use of 4-inch HDPE perforated pipe and connecting the pipes to the concrete vaults. A Quikcrete® concrete was used to seal around the HDPE pipe penetrations into the vault openings.

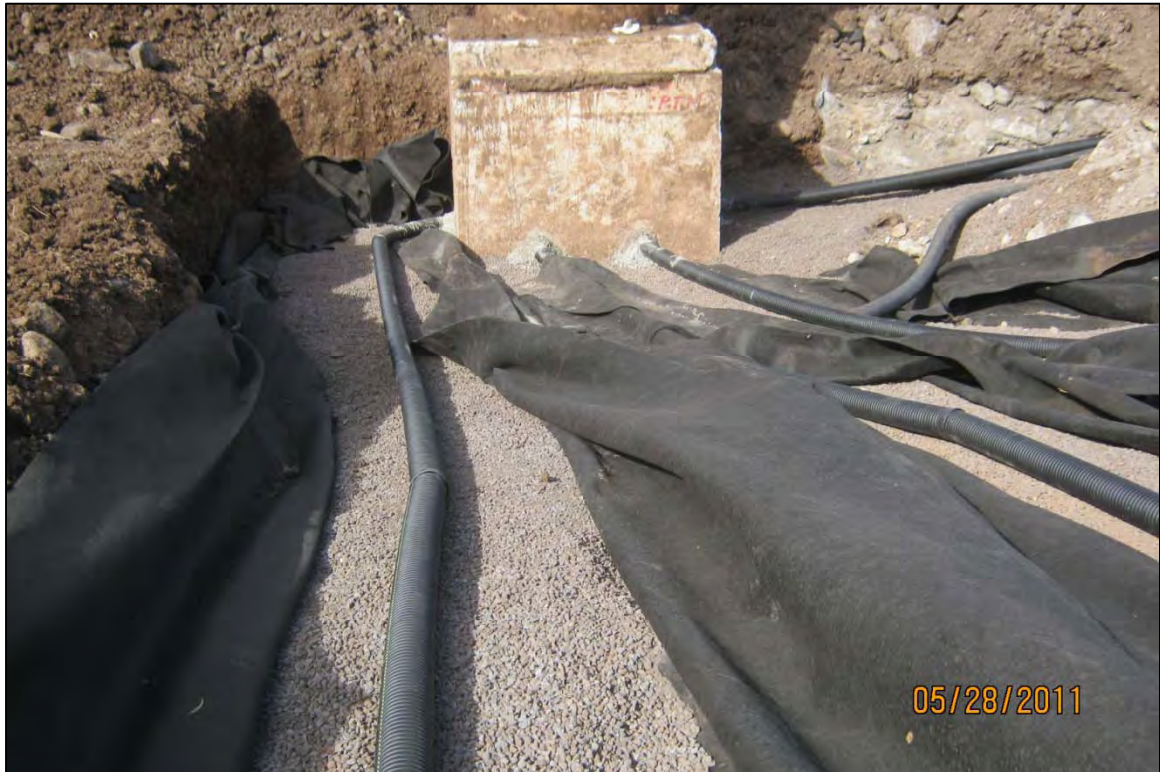
Photo 19: Subdrain pipes connecting into the western concrete riser pipe, looking south.

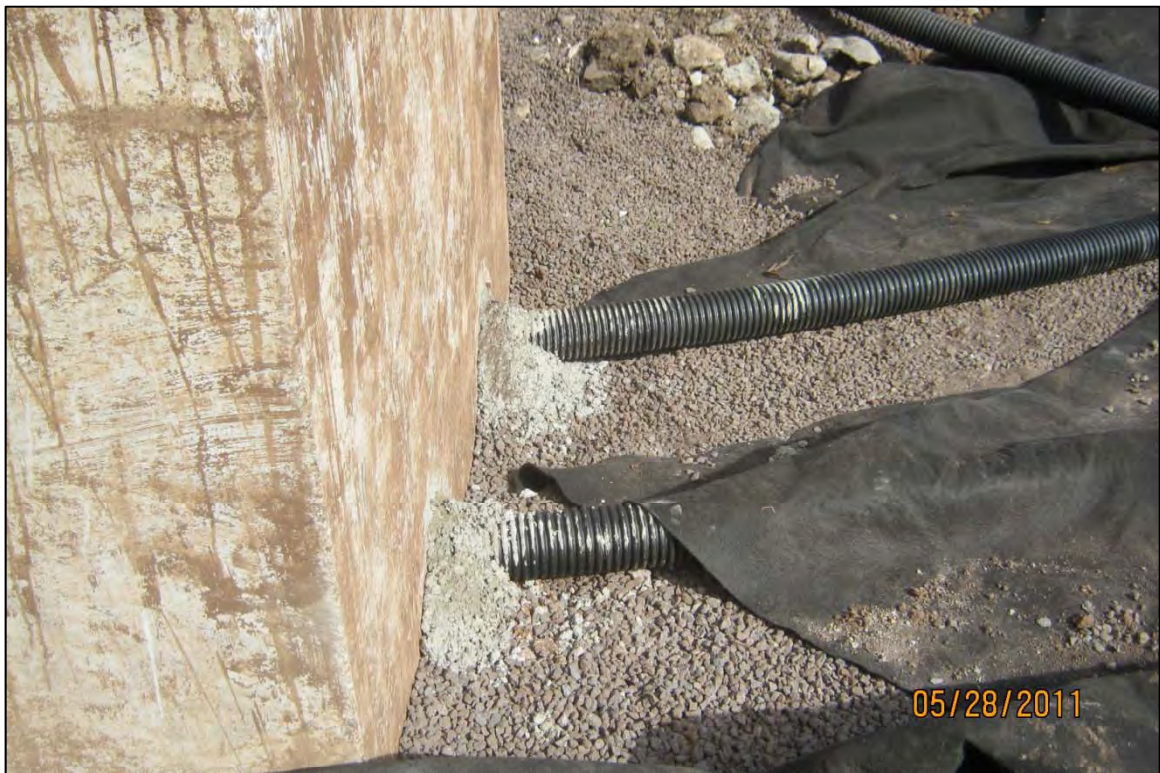
Photo 20: Concrete seal around the connection of the subdrain pipes to the riser vault.

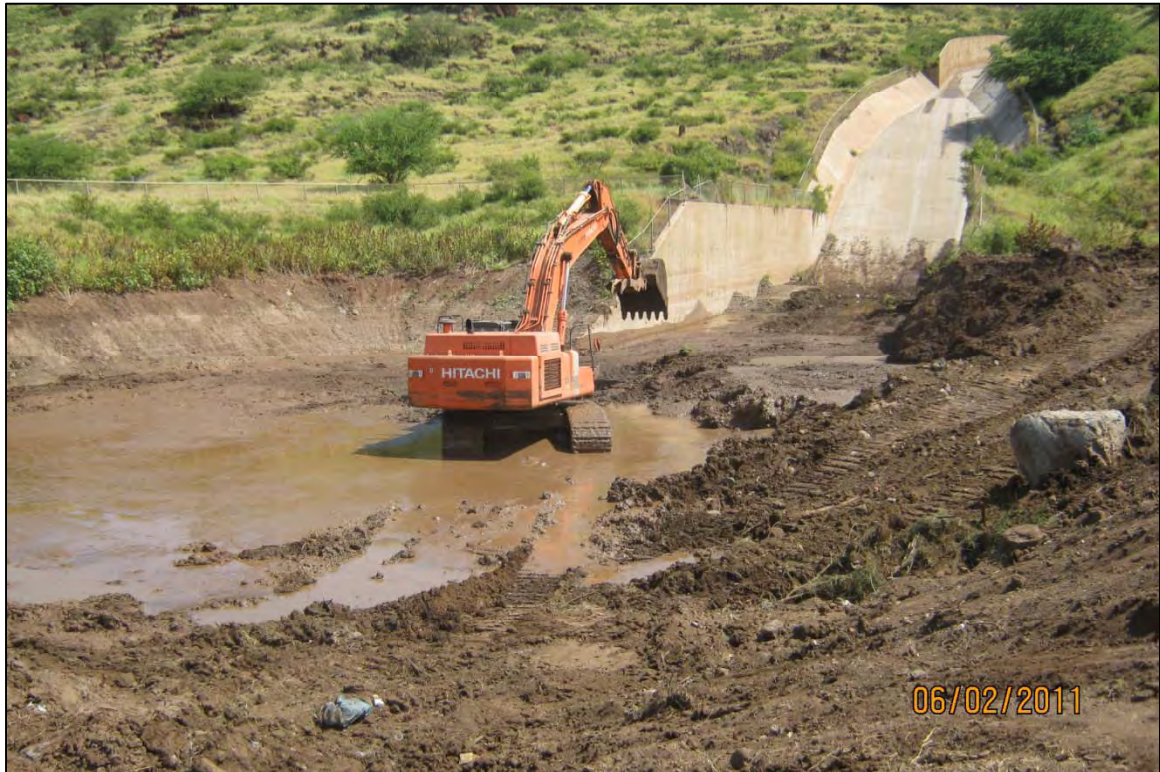
Photo 23: Excavating sediment from the inlet apron area of the northern portion of the sedimentation basin, looking north.

Following removal of sediment from the downstream end of the concrete lined drainage channel in the northern basin area, a 16-oz/yd<sup>2</sup> geotextile was installed along the width of the drainage channel into the sedimentation basin for a length of 30-ft. The geotextile was covered with approximately 18-inch to 24-inch rock, as shown in the design drawings included in the work plan in Attachment 1.

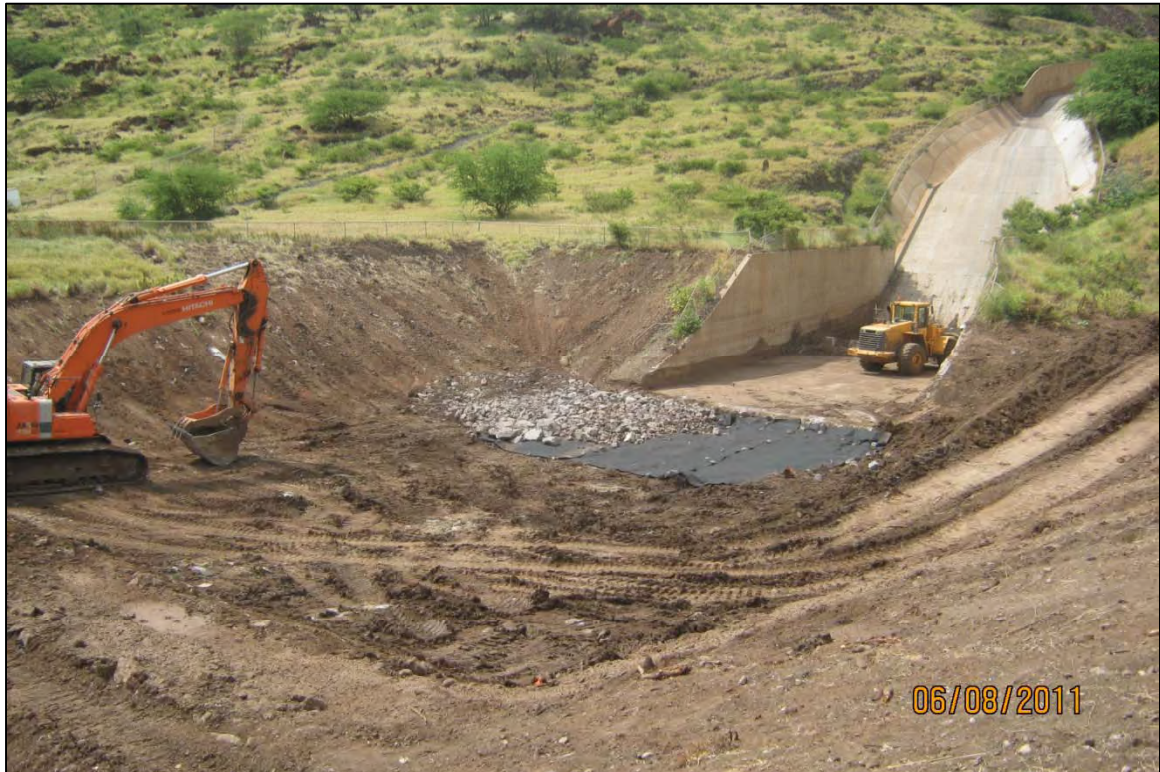
Photo 25: Excavator placing 18-inch to 24-inch rock over the 16-oz/yd<sup>2</sup> geotextile along the inlet apron of the northern portion of the sedimentation basin, loader removing sediment from concrete energy dissipaters in concrete lined channel, looking northwest.

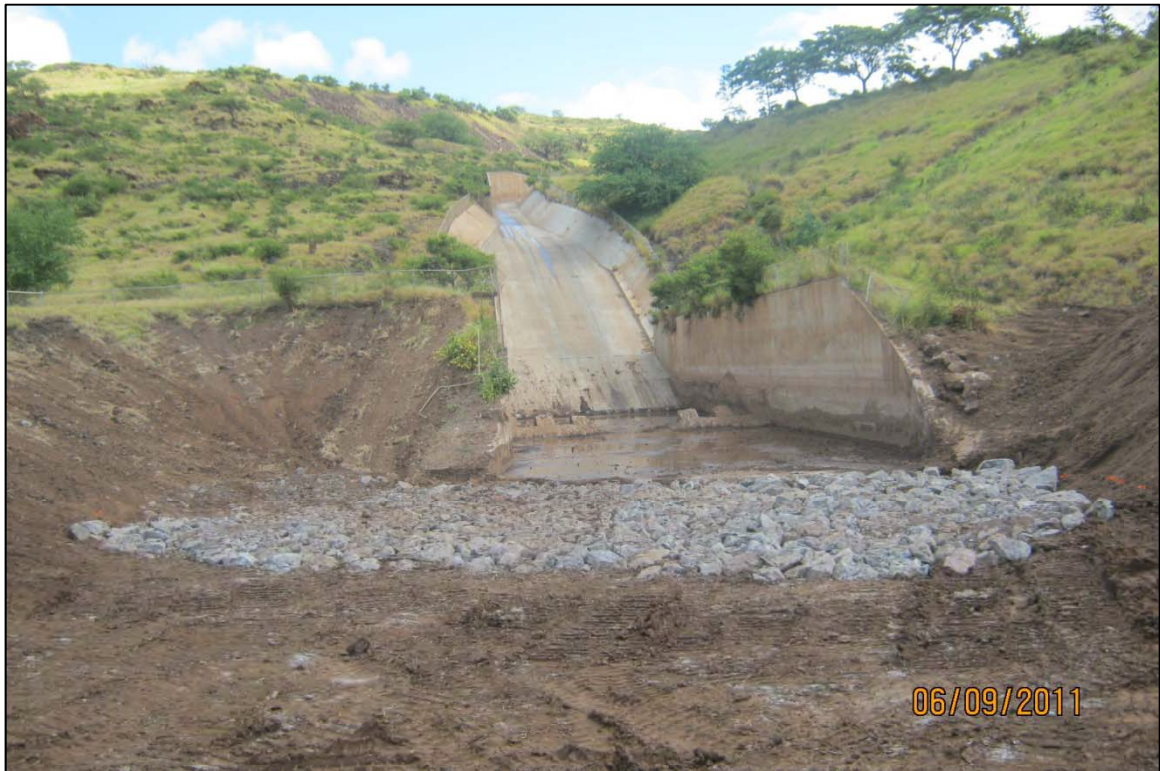
Photo 26: Inlet apron following restoration on the northern portion of the sedimentation basin at the end of the concrete lined drainage channel, looking north.

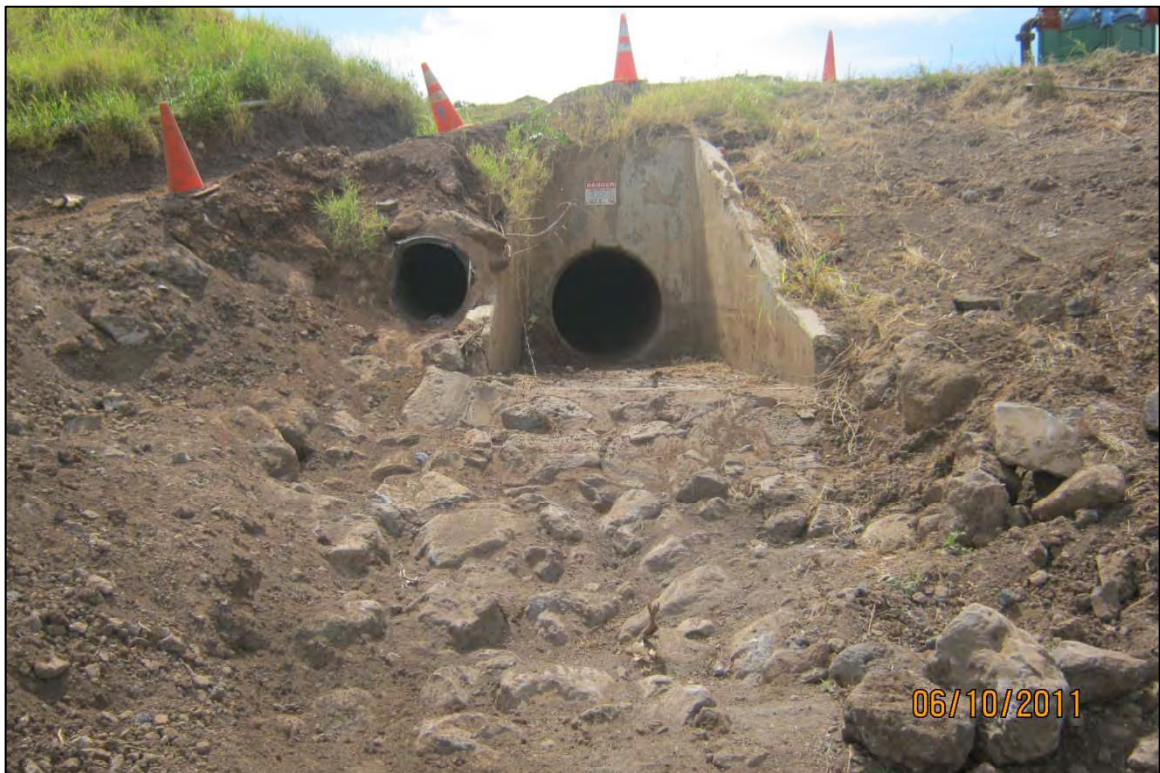
Sediment and rock debris was removed from the grouted rock riprap at the discharge point for the 18-inch and 42-inch storm water pipes into the northeast corner of the sedimentation basin. No damage to the grouted rock riprap at the discharge point was observed.

Photo 28: Rock riprap at the discharge of the 18-inch and 42-inch storm water pipes at the northeast corner of the sedimentation basin

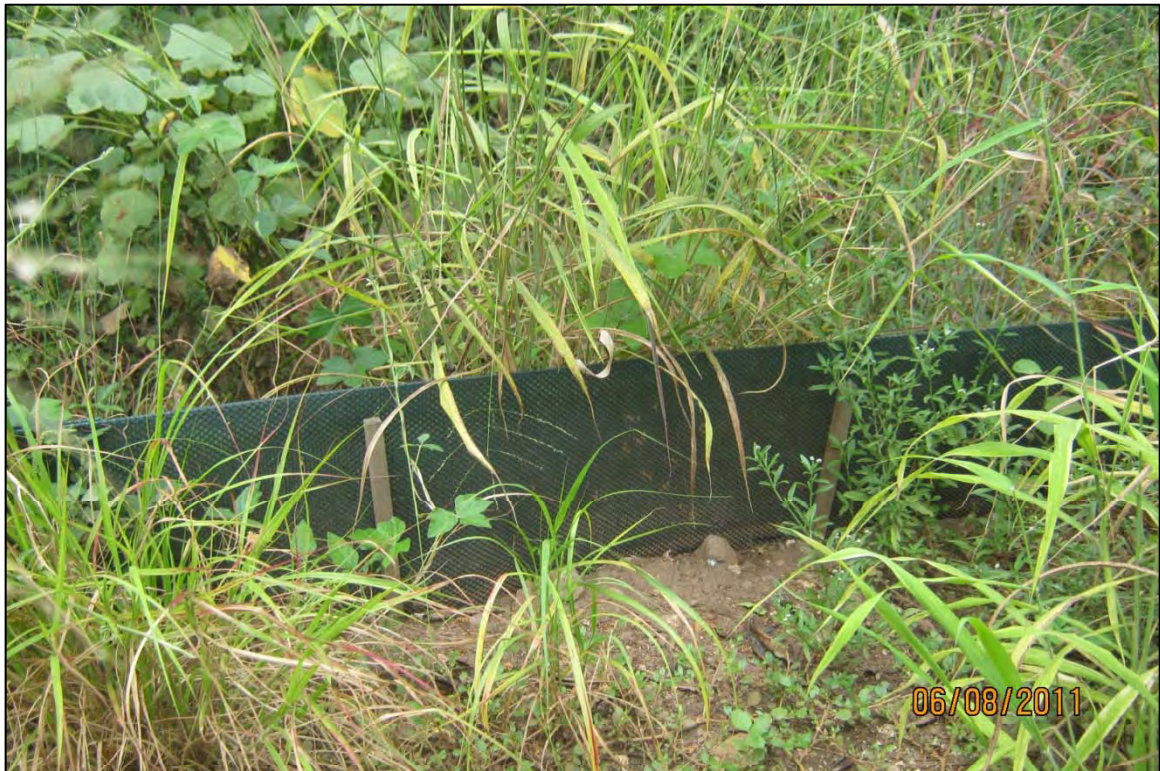
Photo 30: Sedimentation fence installed along the spillway at the southern edge of the vegetated corridor.

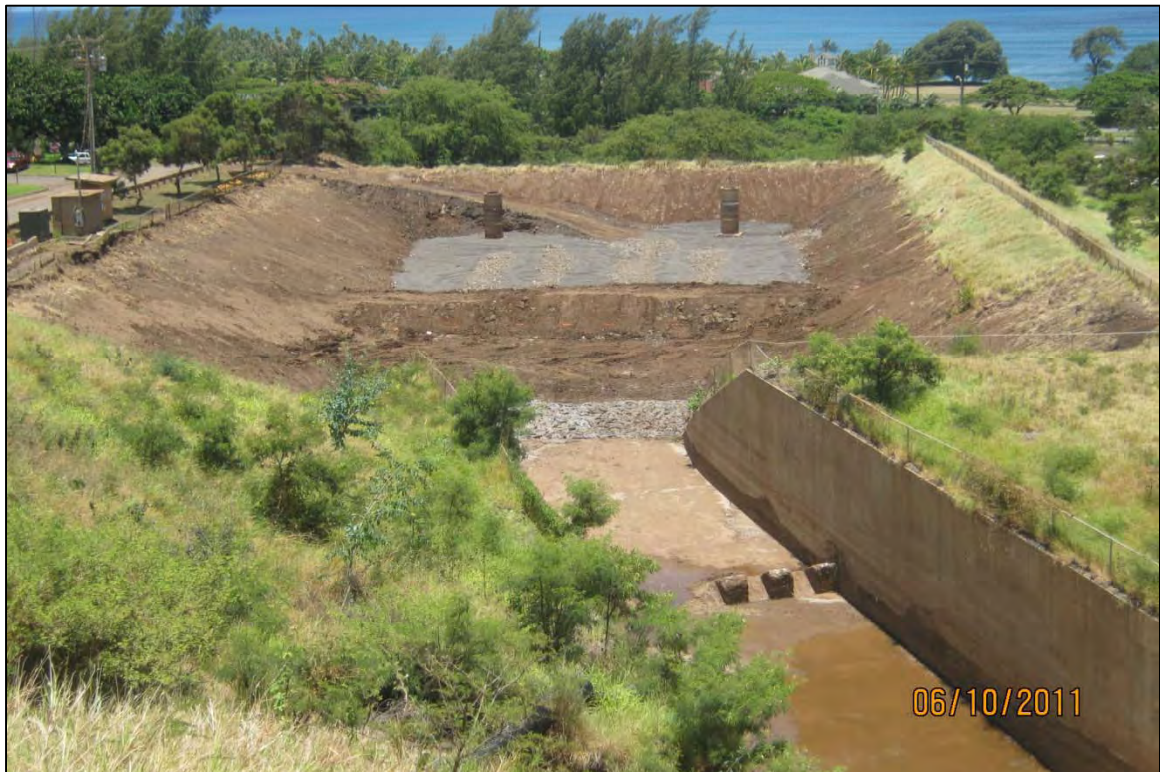
Photo 31: Overview of the sedimentation basin following restoration, looking south.

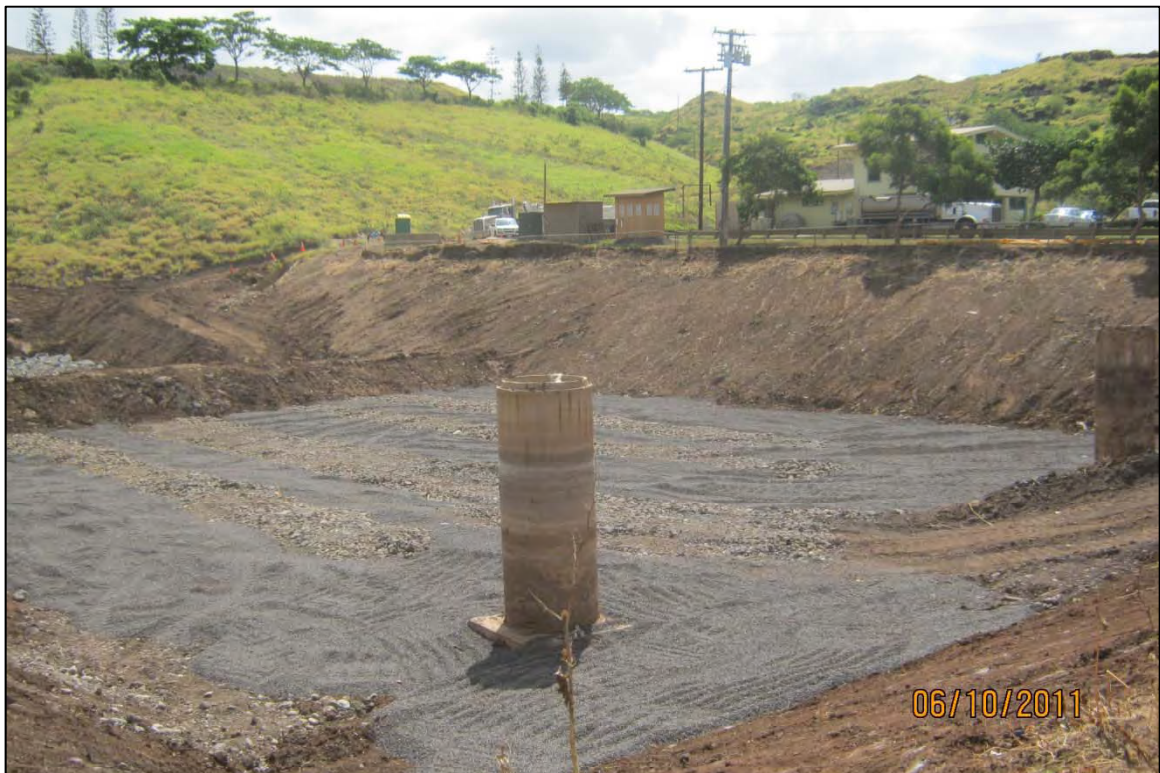
Photo 32: Overview of the southern portion of the sedimentation basin following restoration, looking east.
